SmartBall® Leak Detection Survey

Pure Technologies Ltd.

November 13th, 2008

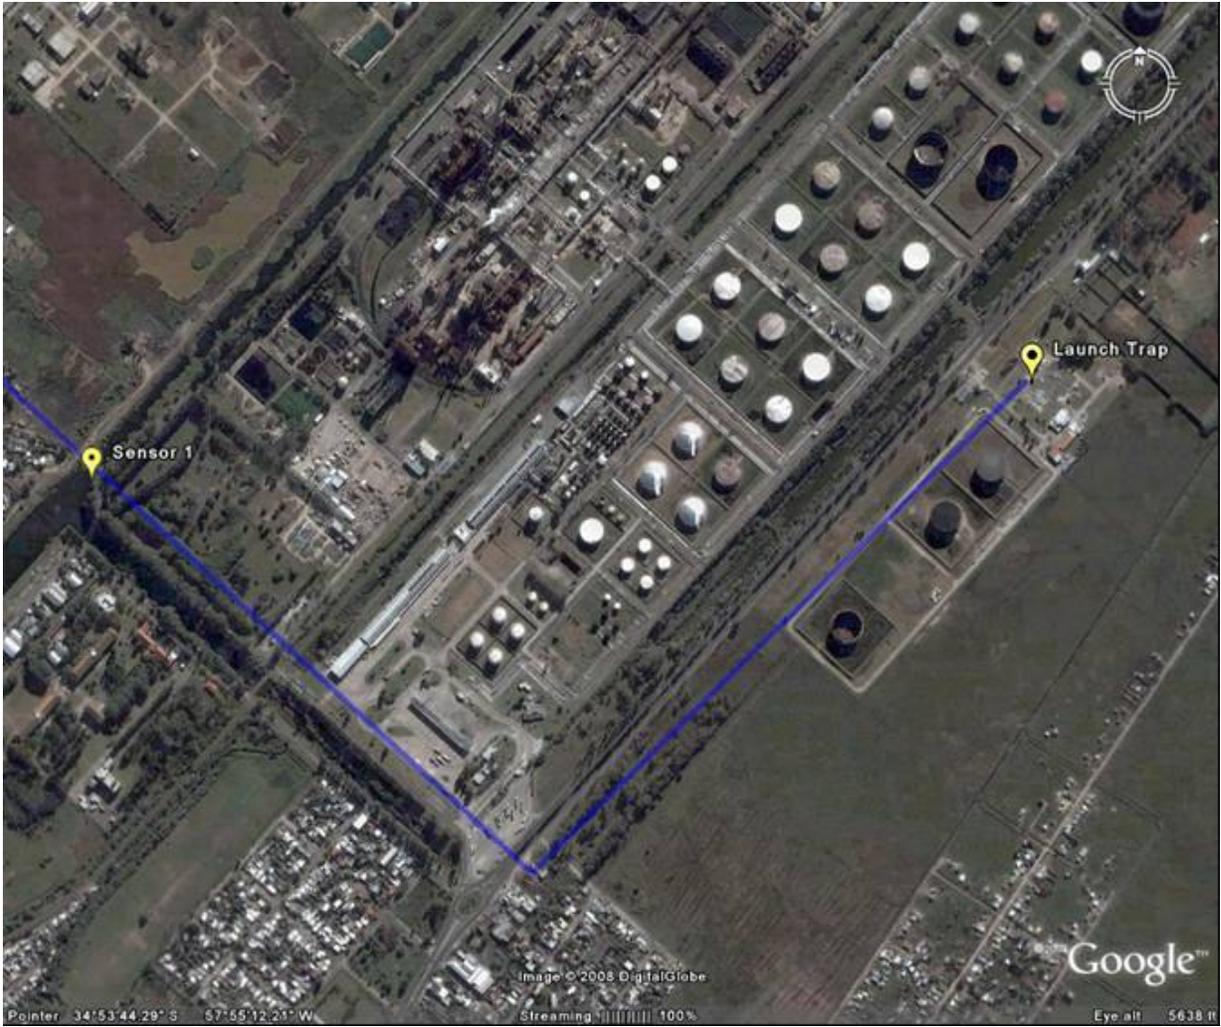
Location of Calibration Leaks and First Tracking Point

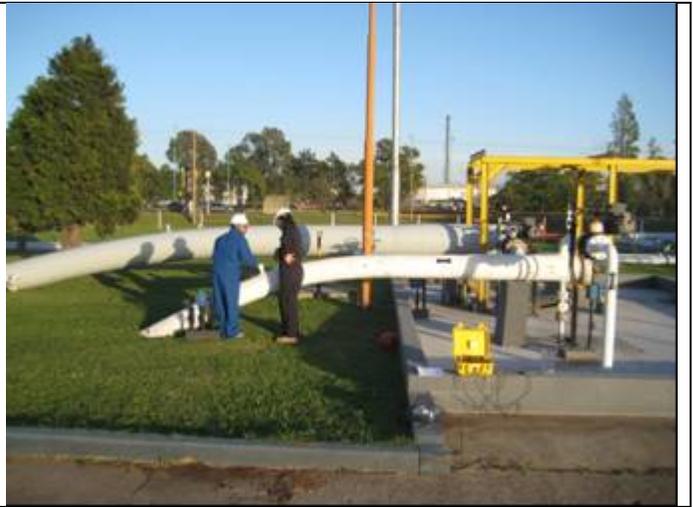
Sensor Location #0:

Sensor Location ID	Insertion Trap	
Distance from Launch	0 meters	
Time of SmartBall tool launch	08:29:00	
GPS Position	Lat:	34°53'37.45463"S
	Long:	57°54'45.20703"W

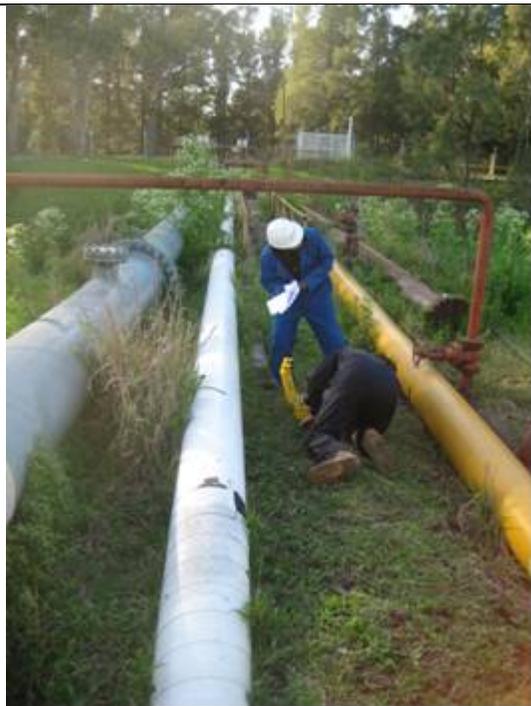
Sensor Location #1:

Sensor Location ID	Ituzaingó Water Crossing	
Distance from Launch	2+043 meters	
Time of SmartBall tool Pass	08:49:39	
GPS Position	Lat:	34°53'41.73"S
	Long:	57°55'45.65"W

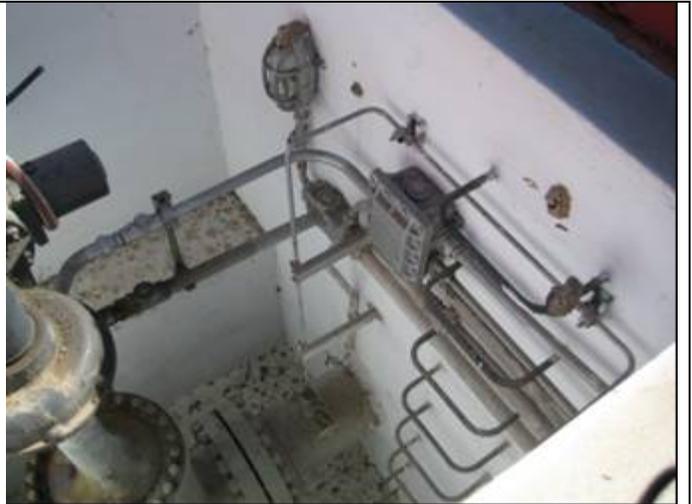
Sensor Location #2:

Sensor Location ID	Valvula de Bloqueo 1 Poli	
Distance from Launch	17+061 meters	
Time of SmartBall tool Pass	11:12:00	
GPS Position	Lat:	34°50'5.60"S
	Long:	58° 4'19.96"W

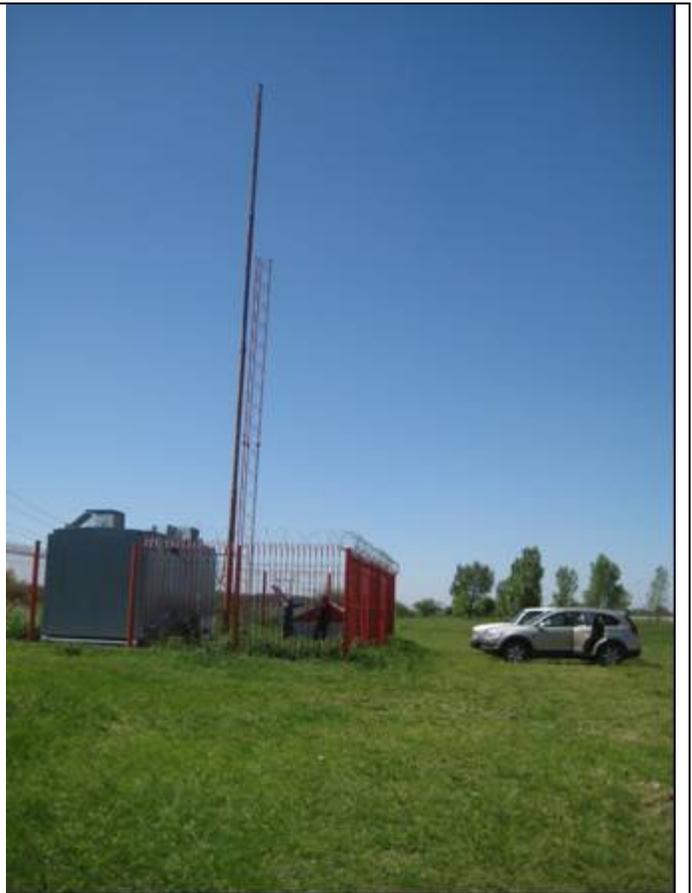
Sensor Location #3:

Sensor Location ID	Valvula de Bloqueo 2 Poli	
Distance from Launch	34+540 meters	
Time of SmartBall tool Pass	14:00:09	
GPS Position	Lat:	34°43'56.95"S
	Long:	58°12'54.98"W

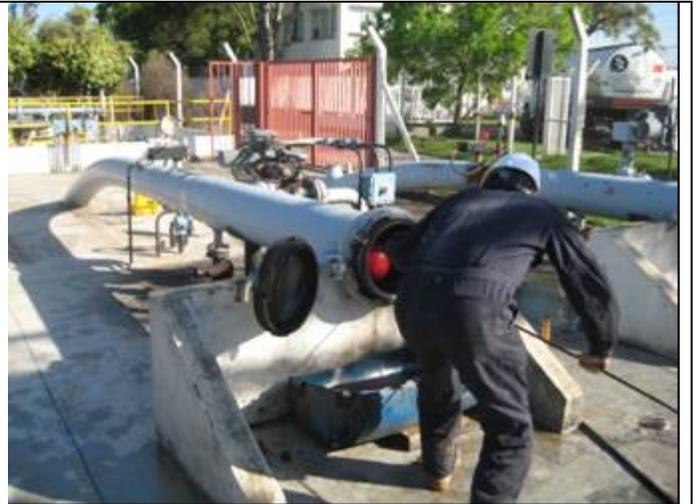
Sensor Location #4:

Sensor Location ID	Receive Trap	
Distance from Launch	52+250 meters	
Time of SmartBall tool Pass	16:54:22	
GPS Position	Lat:	34°38'20.57"S
	Long:	58°20'24.63"W
