Magnetic Flux Leakage (MFL)

What is Magnetic Flux Leakage?

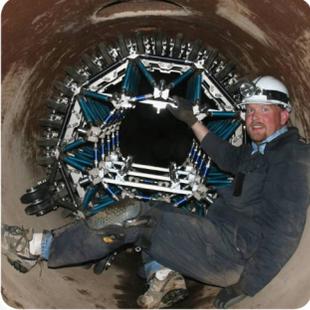
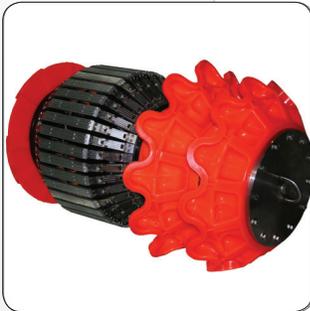
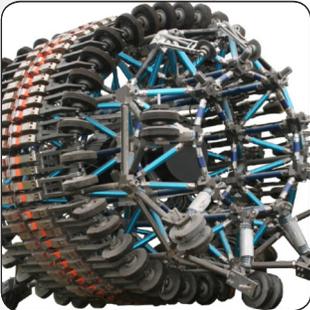
Magnetic flux leakage (MFL) is used to detect corrosion and pitting in lined metallic pipelines.

High powered magnets are used to temporarily magnetize ferrous pipelines. Sensors are positioned to record any deviation in the field. If the magnetic field is uniform, there are no flaws in the wall of the pipe. If internal or external flaws are present, such as pitting or corrosion, the magnetic field is distorted, and this distortion or 'leakage' can be measured by the sensors. Contact with the pipe wall is not a requirement to accurately detect flaws.
